Commercial Historic District Design Guidelines for the City of Litchfield Minnesota

Prepared for
The City of Litchfield

Prepared by
Thomas R Zahn & Associates LLC
Spring 2010

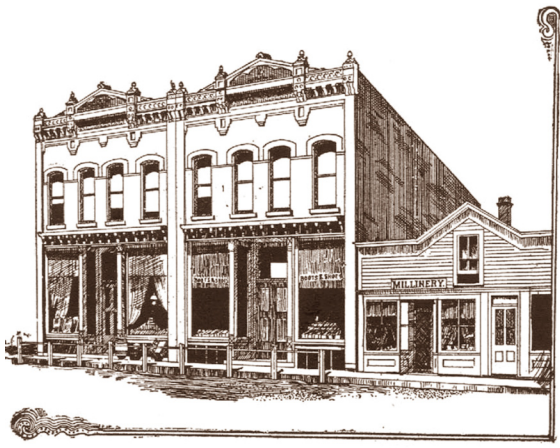
*Line drawing of the storefronts at
223-225 Sibley Avenue North as they appeared in 1889.*

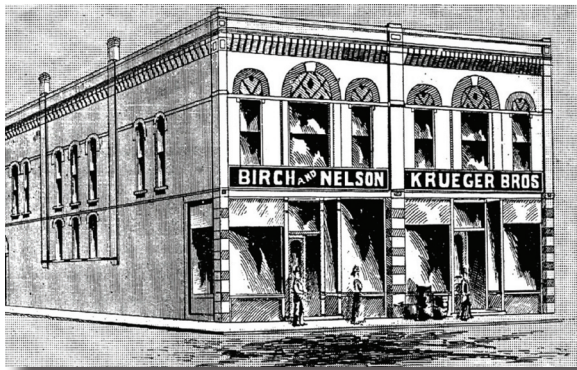
The Masonic Building, built ca. 1889, displays the influence to Romanesque Revival architecture that became popular in the late 19th Century.

The "Romanesque" style, dating back to the late 19th century, was not as widespread in Minnesota as the Italianate. This style's name came from the extensive use of the rounded arch in early Roman construction. The American architect, Henry Hobson Richardson, in the mid-nineteenth century began using heavy masonry construction and rounded arches. The "Romanesque Revival" style quickly developed throughout the country, especially in the construction of warehouses and office buildings. An outstanding example of the Romanesque Revival style is seen in the Masonic Building at 242-244 Sibley Avenue North.

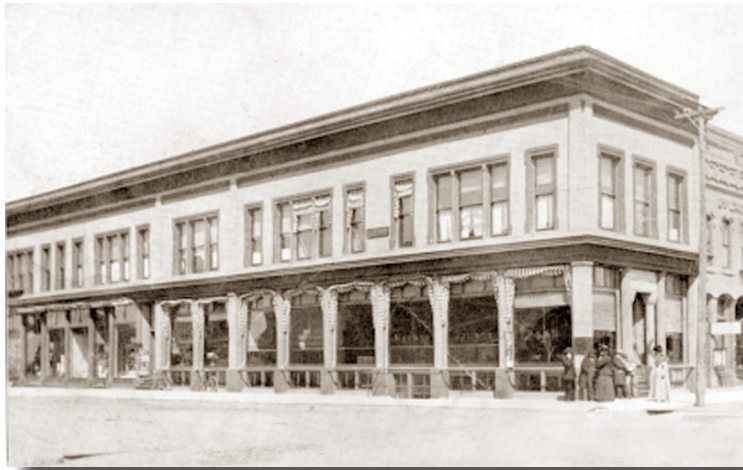
The Meeker Bank as it appeared in 1898.

of Paris on American architecture, developed into the Classical Revival Style. This was a popular style throughout the country from the 1890s to the 1920s. The main characteristic of this style is a more academically correct use of classical forms including cornices, columns and pilasters, and porticos, etc. The Meeker/First National Bank at 201 Sibley is an example of a Classical Revival building that has been modified over time. As built in 1898, the bank structure displayed a heavy cornice and a formal entry flanked by two column sets at the doorway. The intact classical features include the formal rectilinear window pattern and the "egg and dart" motif surrounds and crowns on the upper story windows."

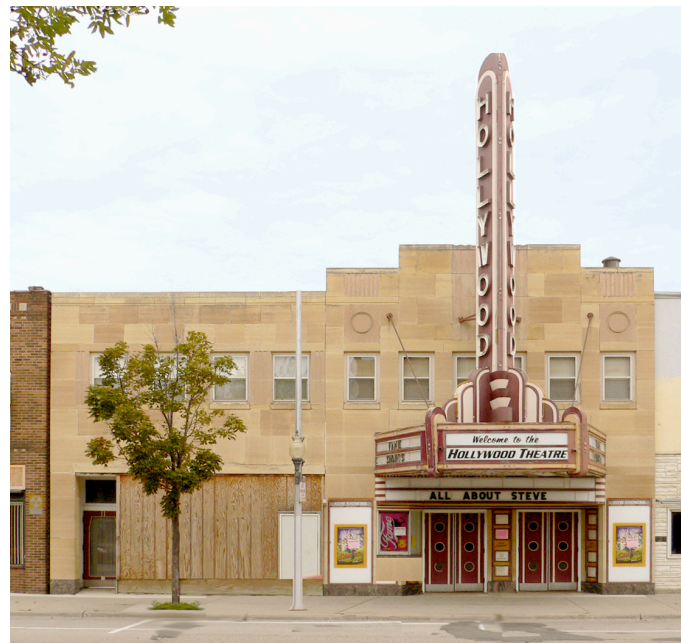
The start of the 20th century saw the introduction of the Art Deco style commercial architecture in Minnesota. Litchfield has a good example of this modern movement in the Hollywood Theatre exterior located at 210 Sibley Avenue North.

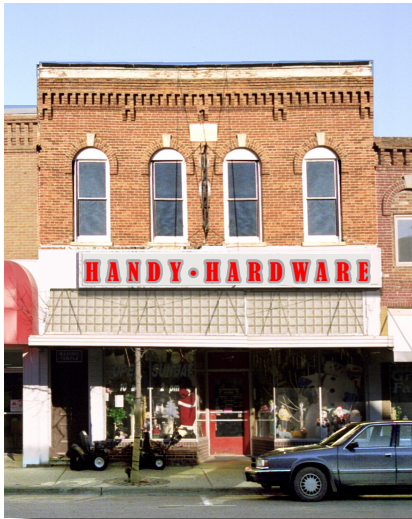
Backlit plastic signs and underlit awnings with lettering are inappropriate for historic buildings.

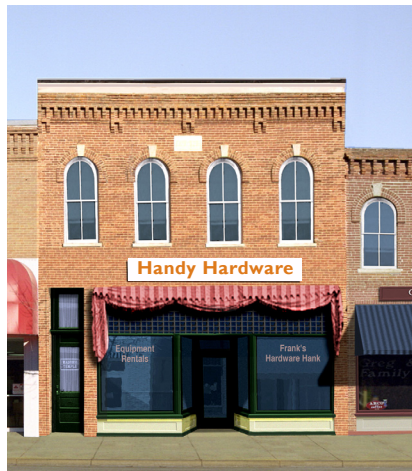
Flat signboards, low-profile projecting signs, painted lettering on the display windows and awning valance are appropriate.

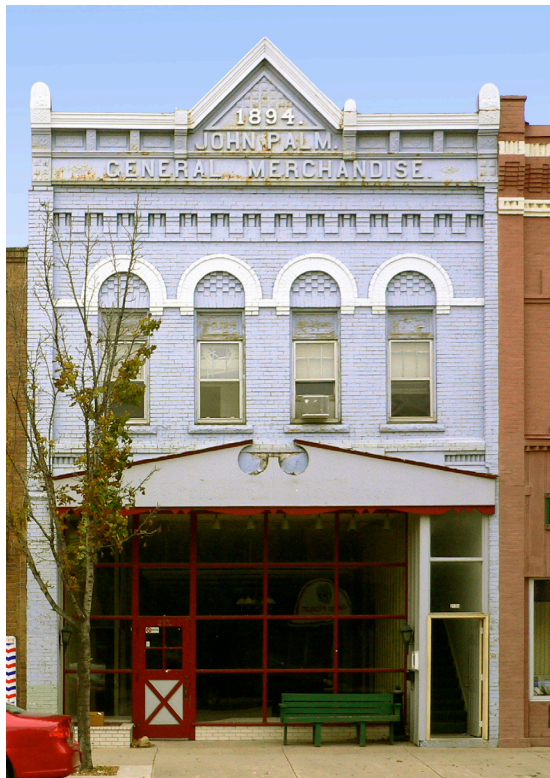
Existing Condition

The storefronts have been modified with modern treatments and materials.

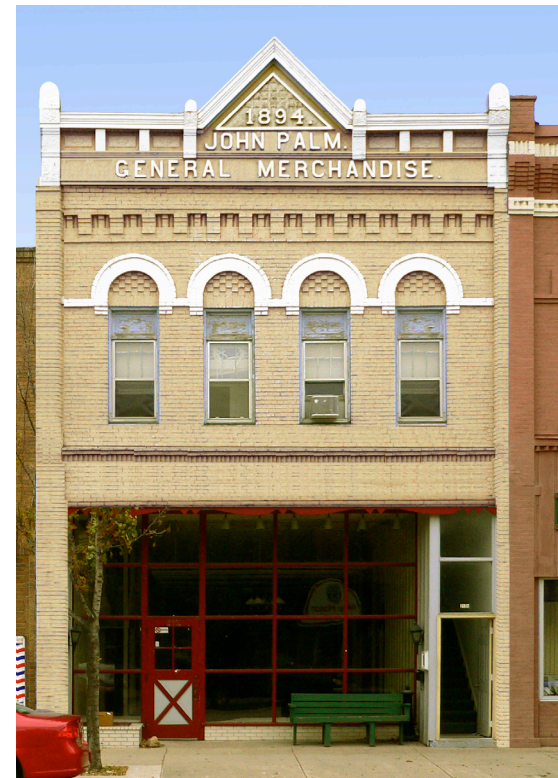
Phase 1

Removing the pediment plywood form over the storefront.

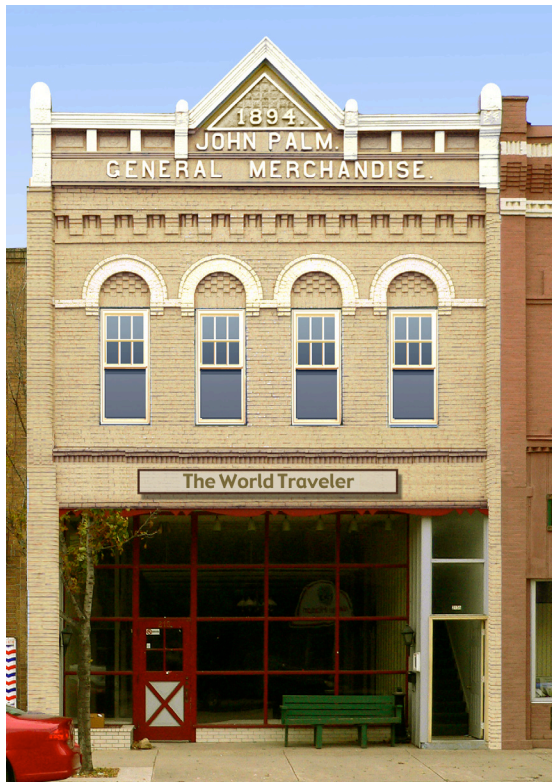
Phase 2

Returning upper story windows to their original 6-Over-1 configuration.
Apply appropriate signage on a flush signboard above the storefront.

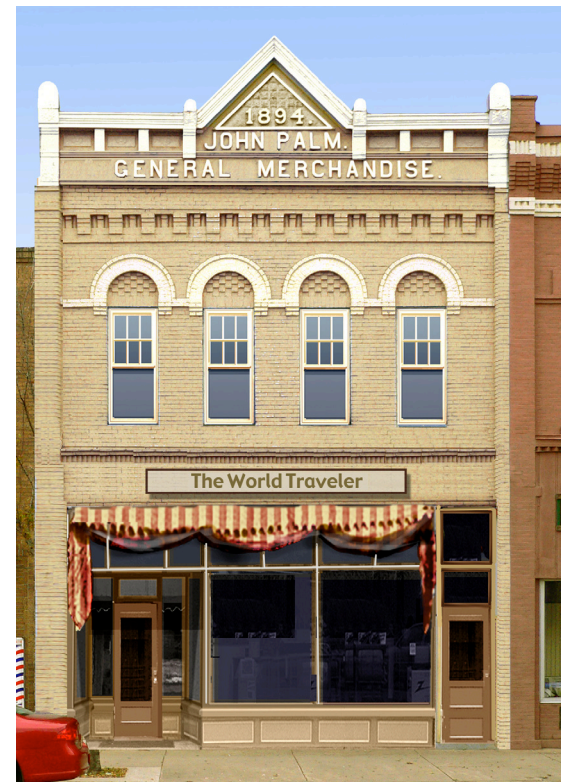
Phase 3

Rebuild storefronts as originally designed with large display windows with transom above and a bulkhead below.
Place retractable canvas awnings over the new display windows.

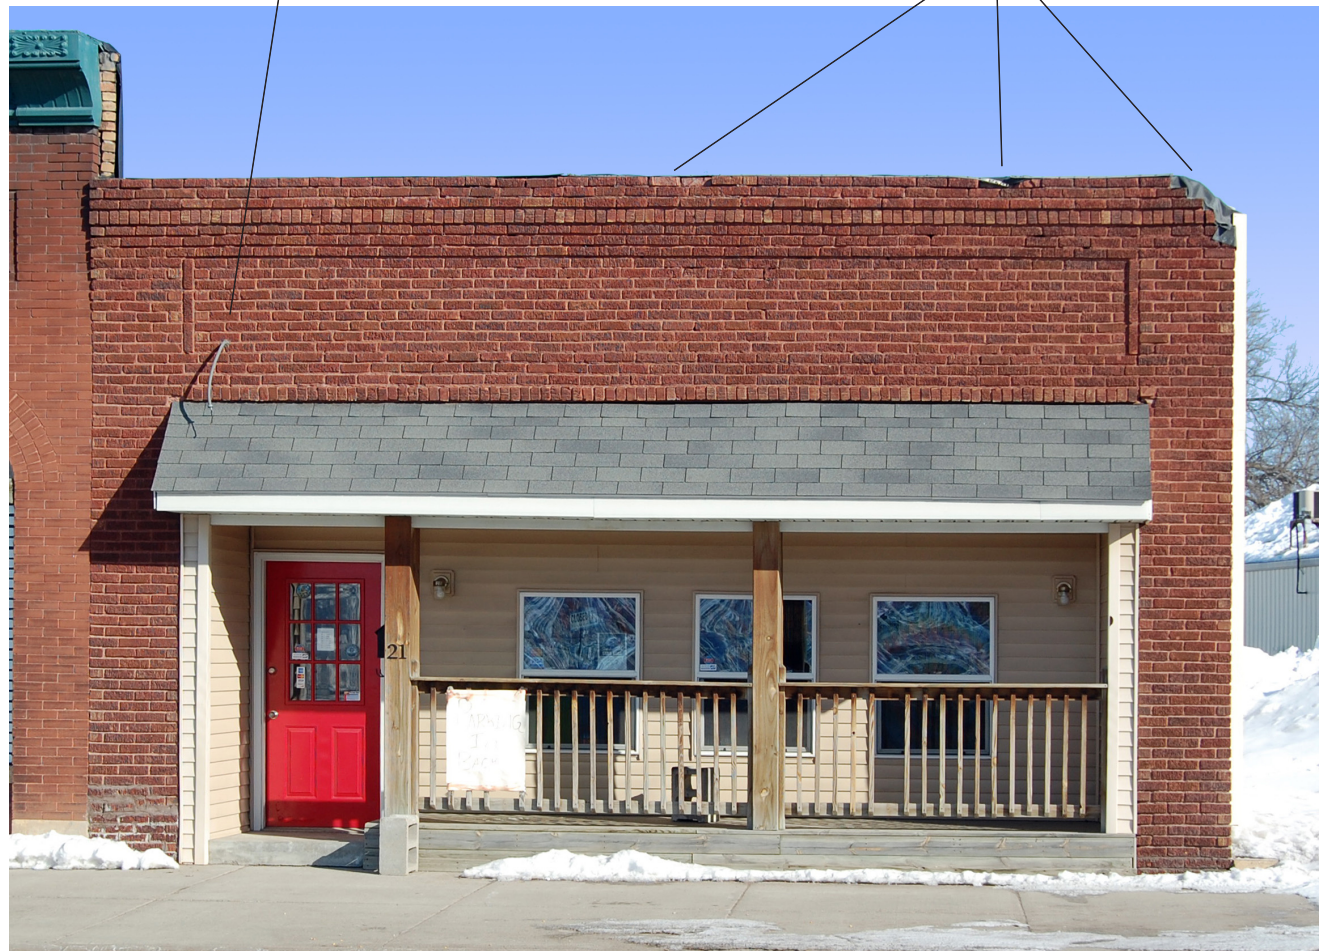
EXISTING CONDITION

Over time the cornice brick has suffered some damage especially at the upper eastern corner.

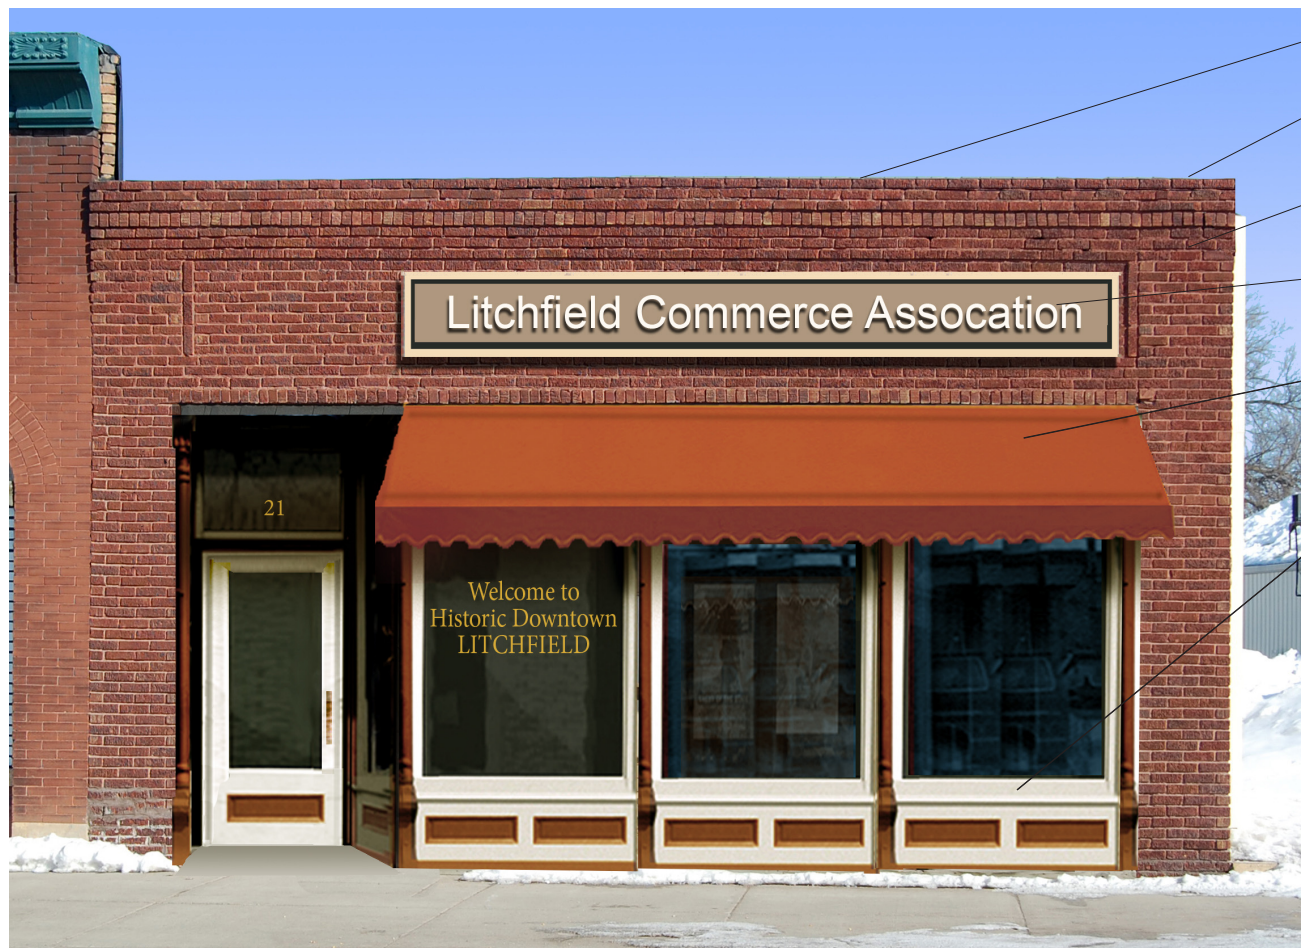
PROPOSED RENOVATION

Inspect roofing, coping and flashing.

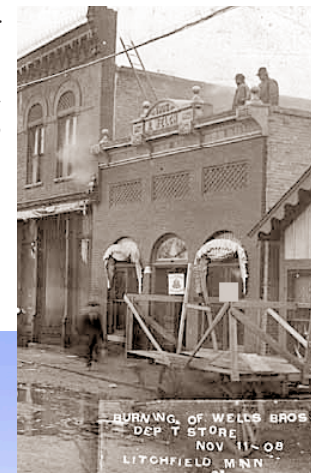
In November of 1908, two years after construction of the R. Welch Building, there was a fire next door in the Wells Bros. Department Store. This photograph shows the building's original fenestration with retractable awnings.

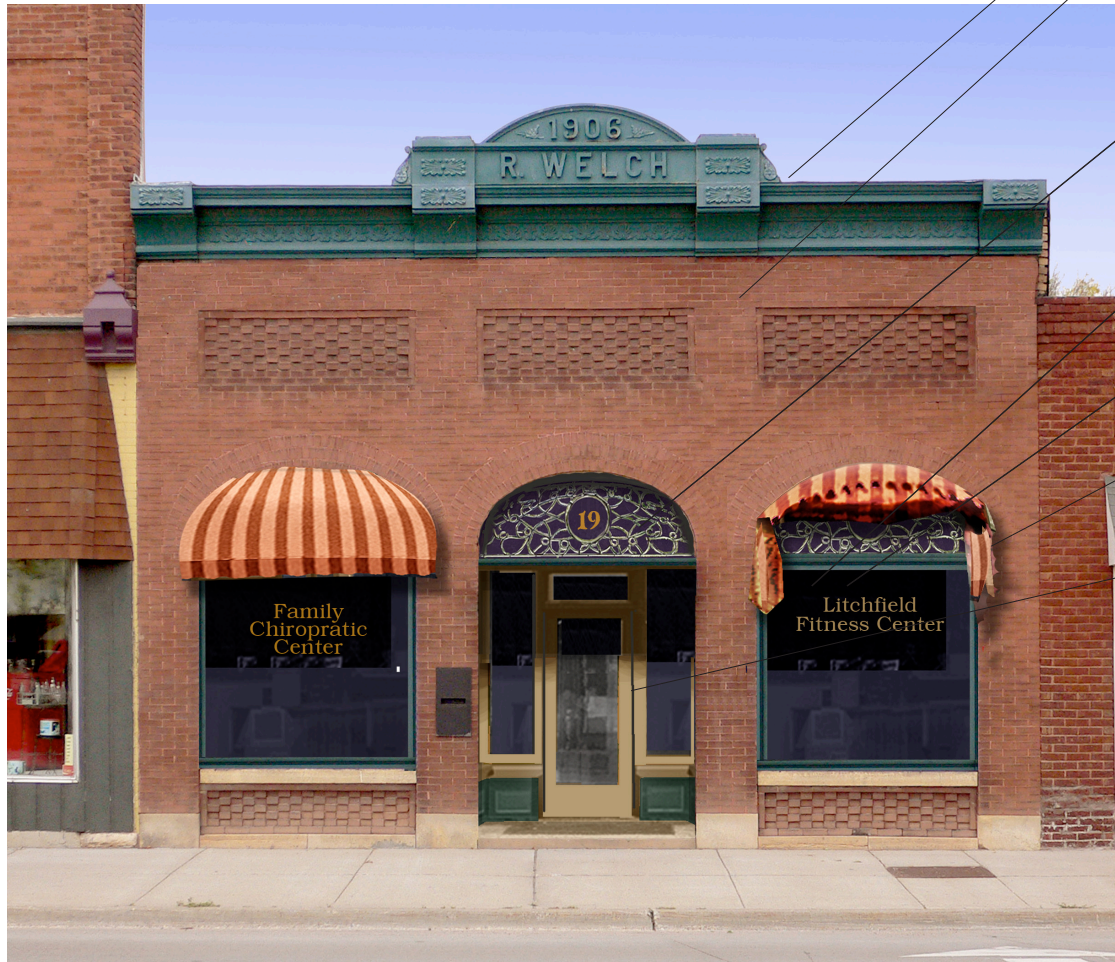
PROPOSED RENOVATION

Inspect roofing, coping and flashing.

Repair, clean and tuckpoint brick as necessary with special attention to areas that show water damage on upper corners.

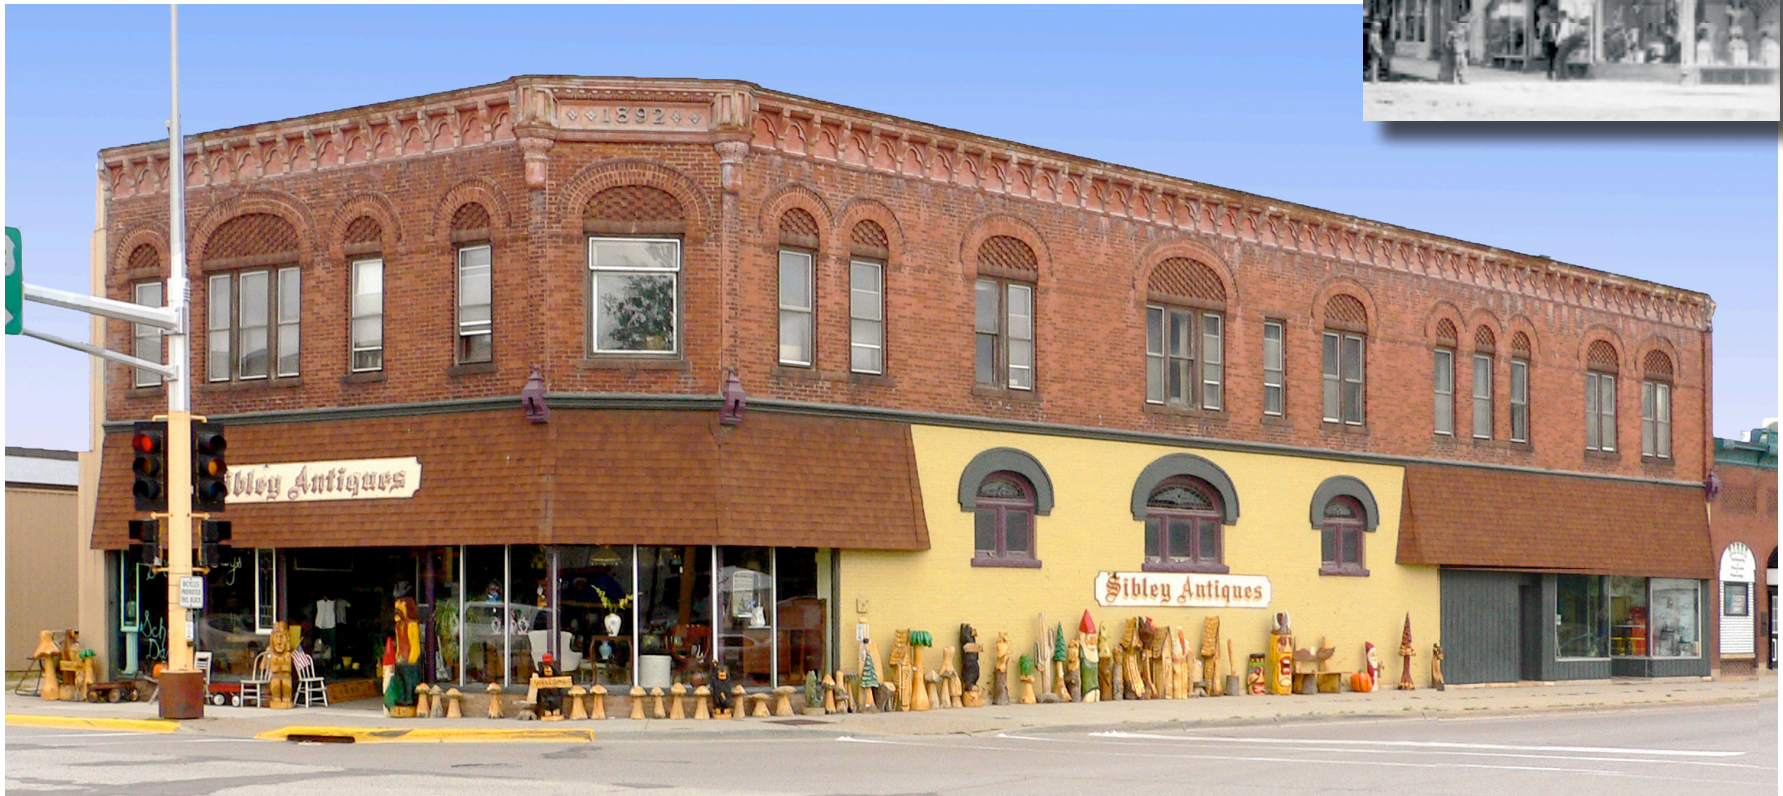
The most prominent changes to the building appear at the cornice and pedestrian levels. The elaborate metal cornice crown once at the southwest corner has been removed. The center brick portion of the south-facing facade at street level is painted a bright mustard color. Tall, shallow-projecting pent roofs cover the south and south/west facing storefronts. The date "1892" is visible in the brickwork above the corner entrance.

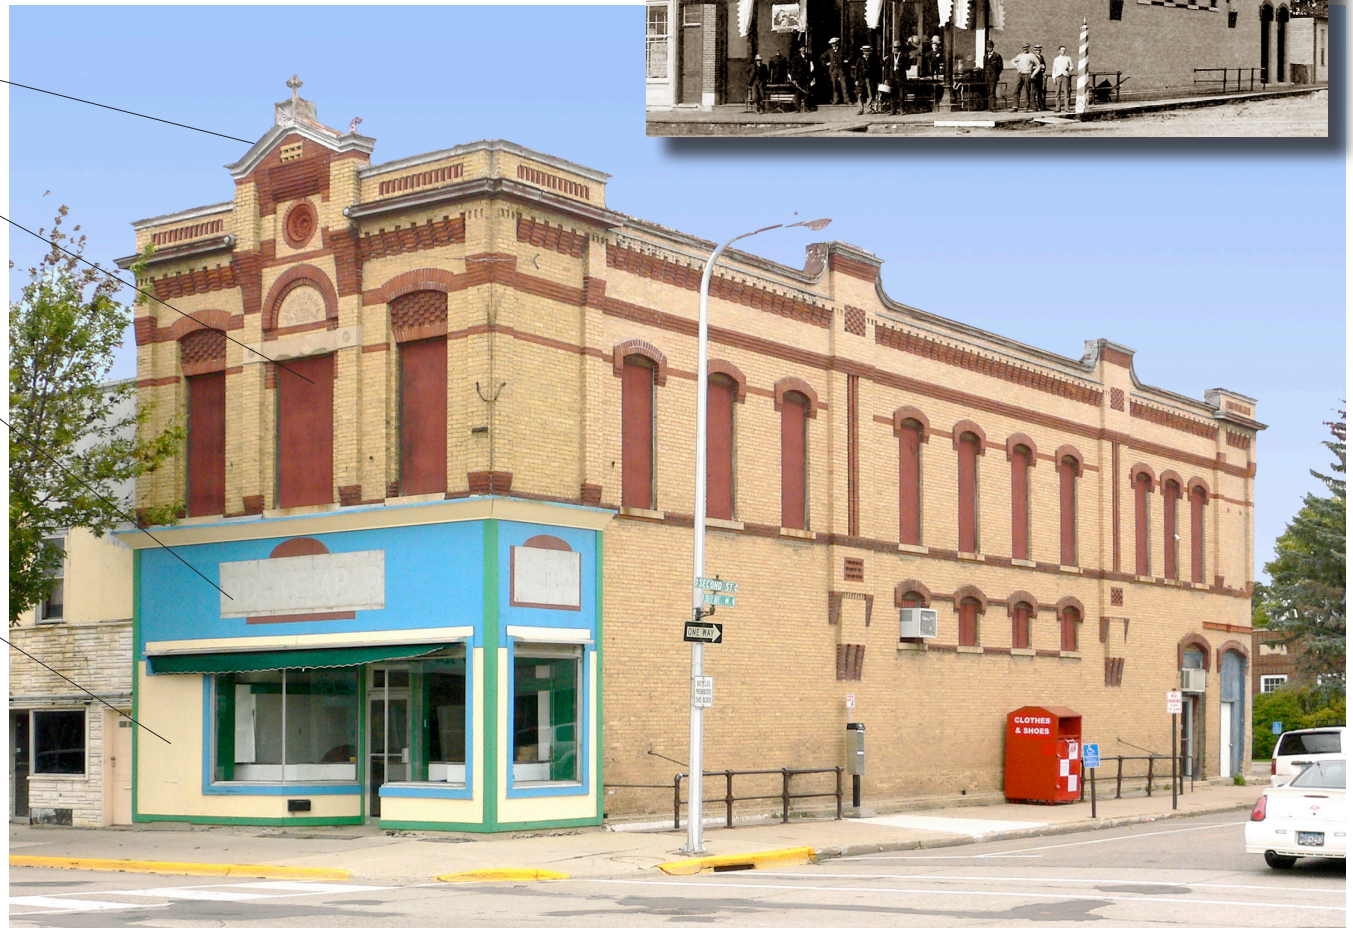
PROPOSED RENOVATION

Inspect roofing, coping and flashing.

Reconstruct storefront with large display windows, centered recessed doorway, transoms above and bulkhead below.

Add more appropriate doors and transoms to entrances on 2nd Street.

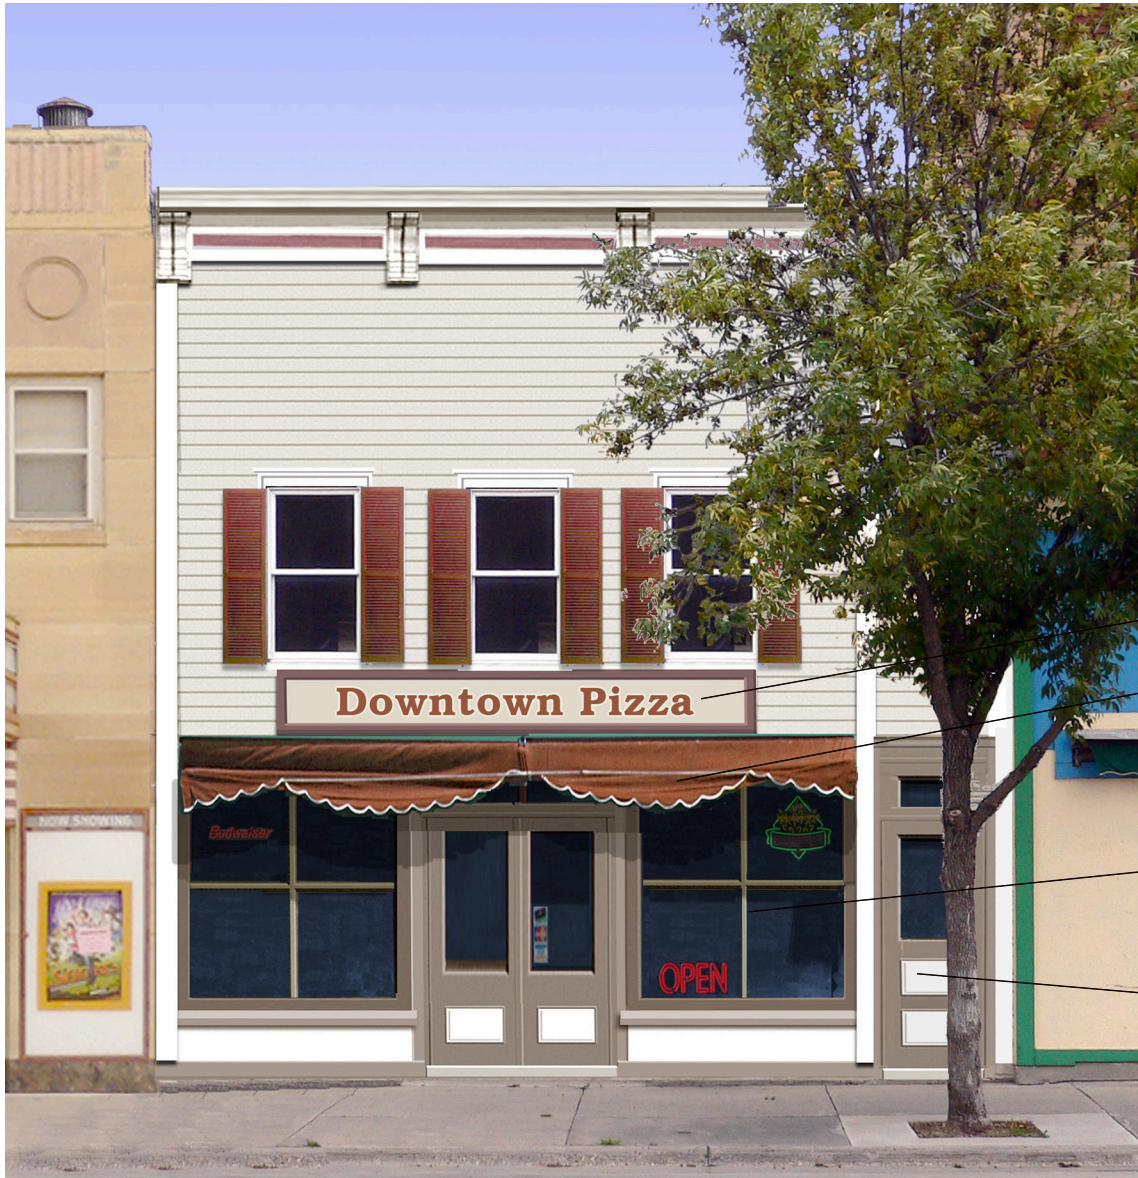
PROPOSED RENOVATION

Inspect roofing, coping and flashing.

Install new wood crown to front facade.

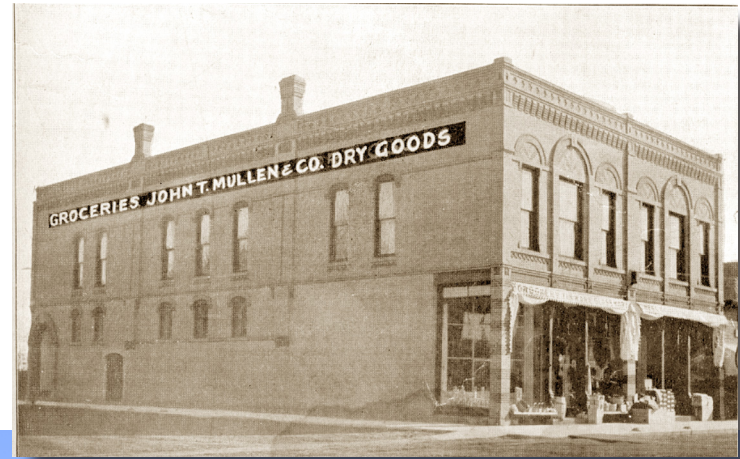
This vintage photograph shows the Masonic Building as it appeared at the turn of the century with its double-hung windows and 2 store fronts intact..

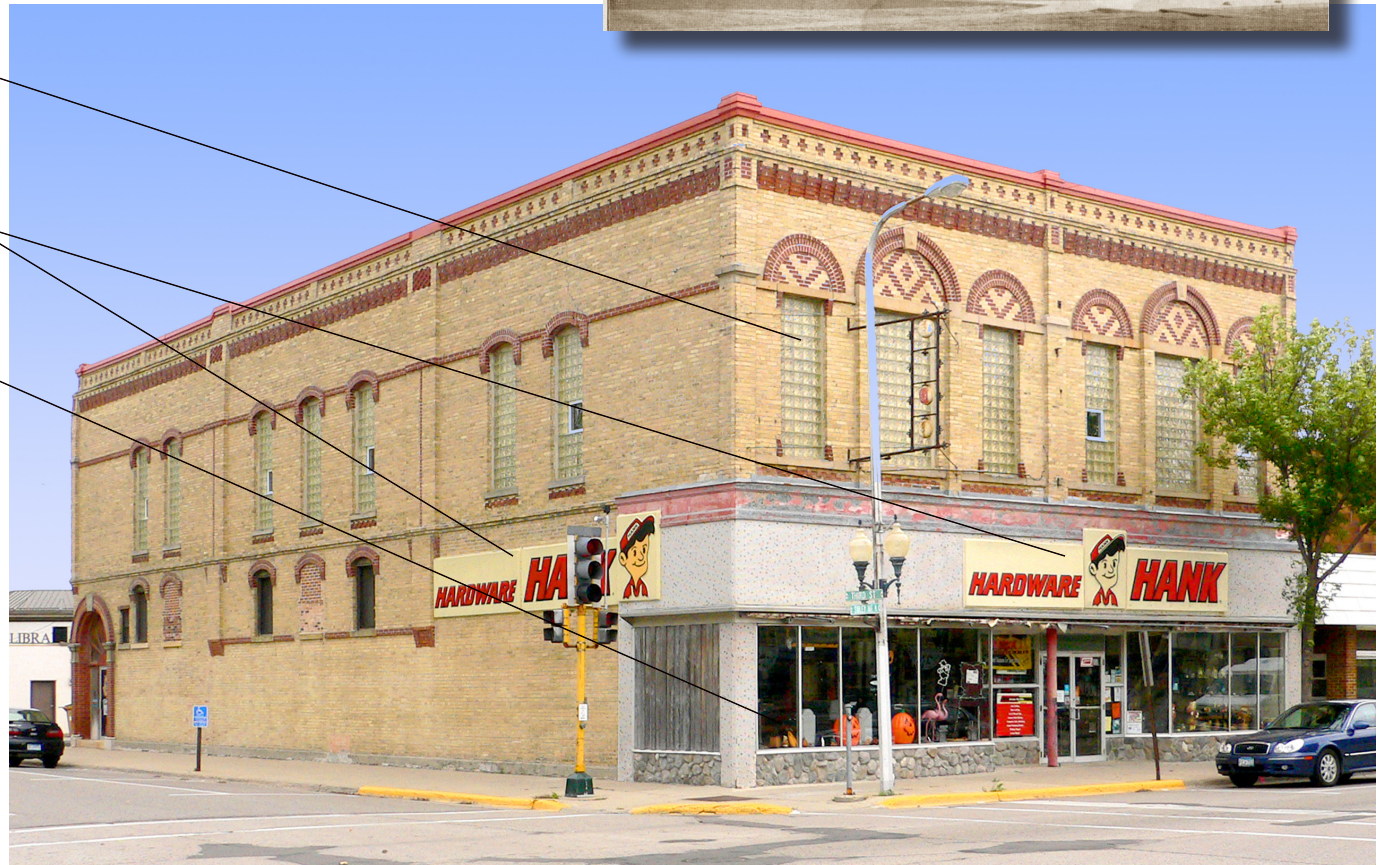
Original upper-story windows have been infilled with glass block.

Storefront has been replaced with modern aluminum-framed windows and stock metal doors.

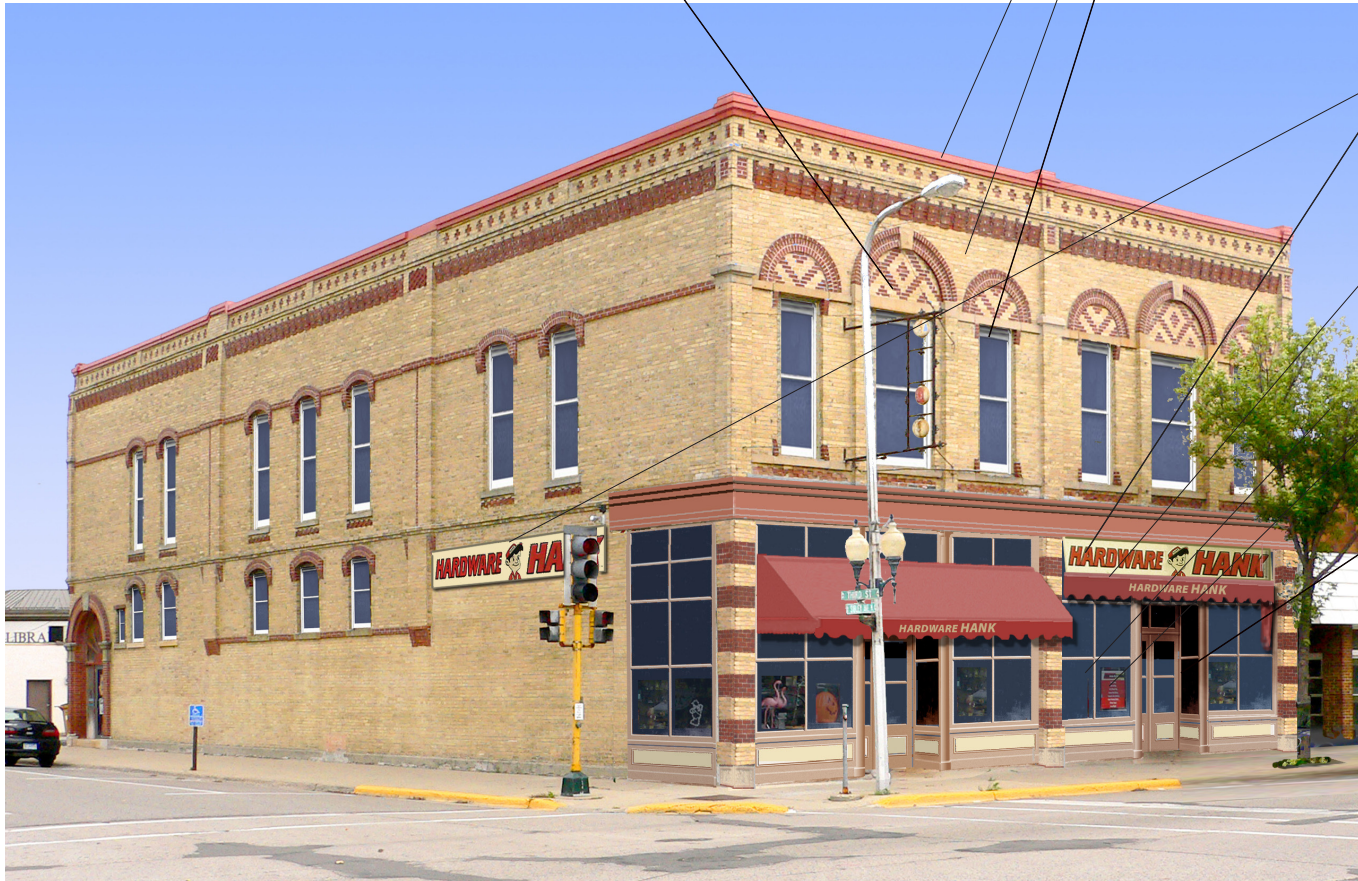
Replace the modern metal doors with wood-and-glass doors.

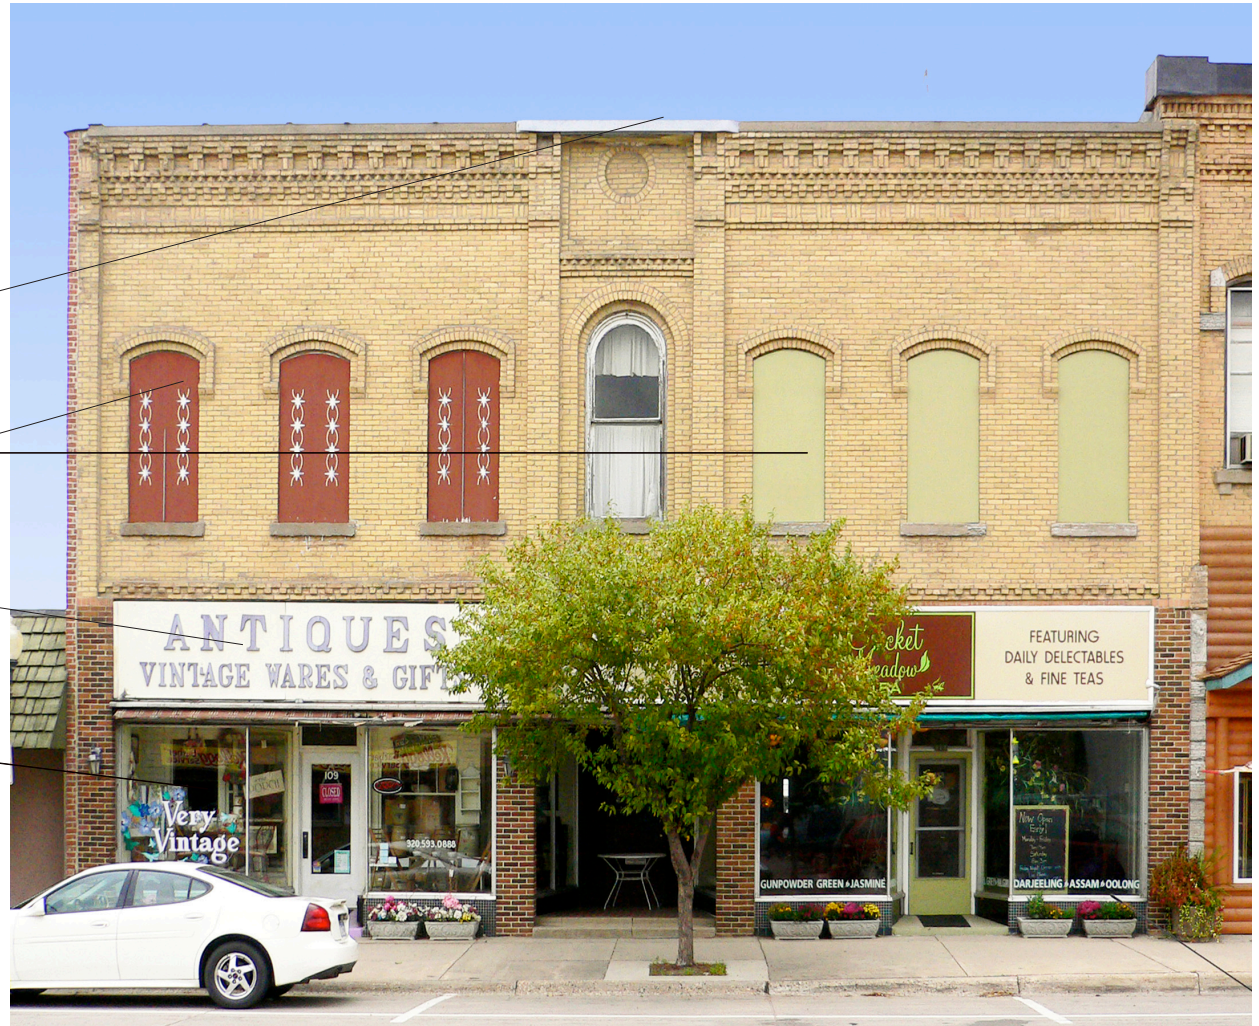
EXISTING CONDITION

Original storefronts have been infilled with modern treatments.

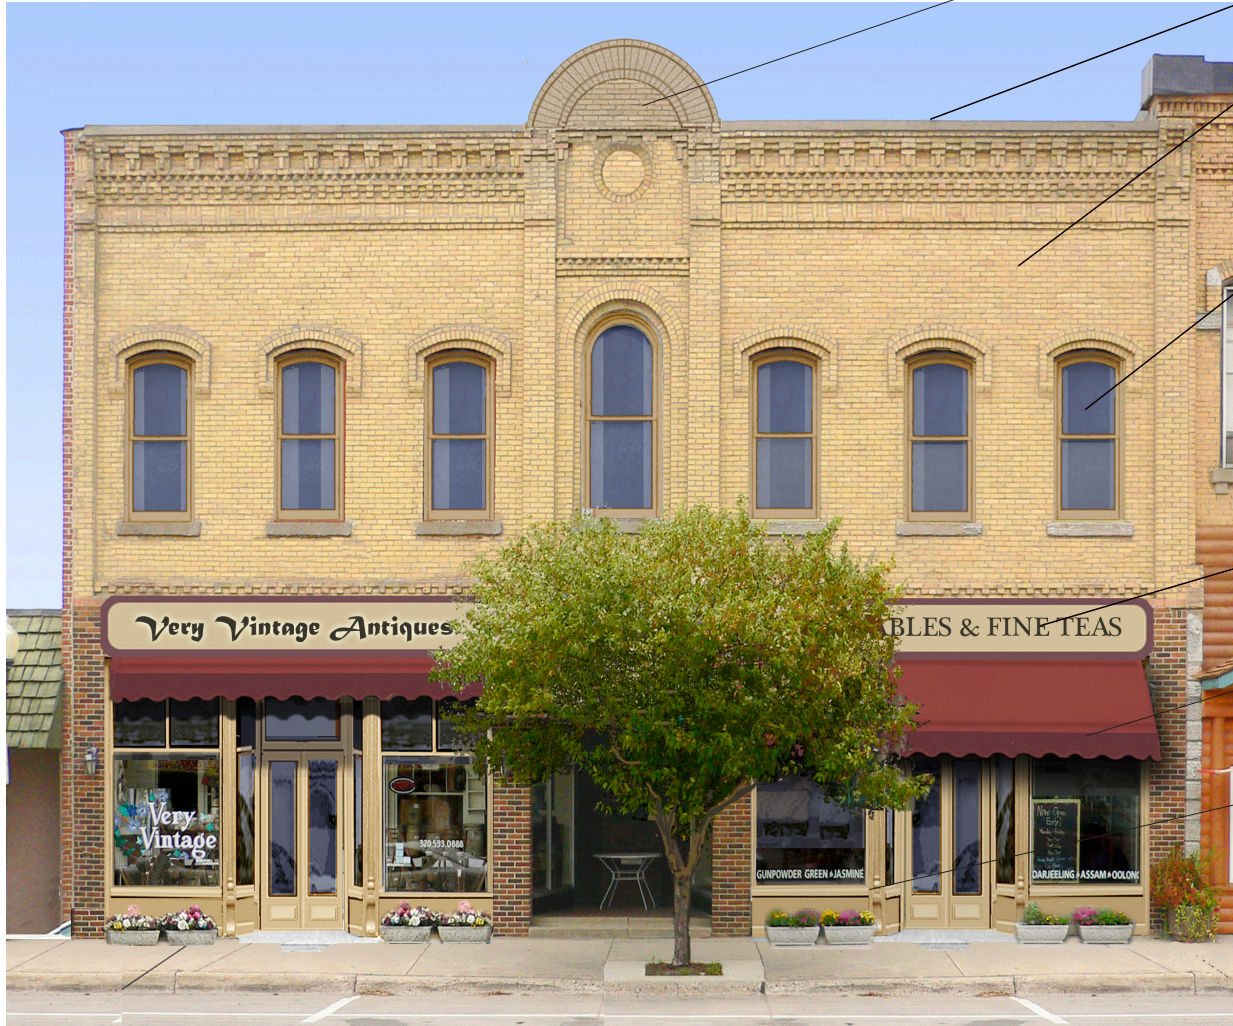
PROPOSED RENOVATION

Consider rebuilding masonry cornice crown over center bay.

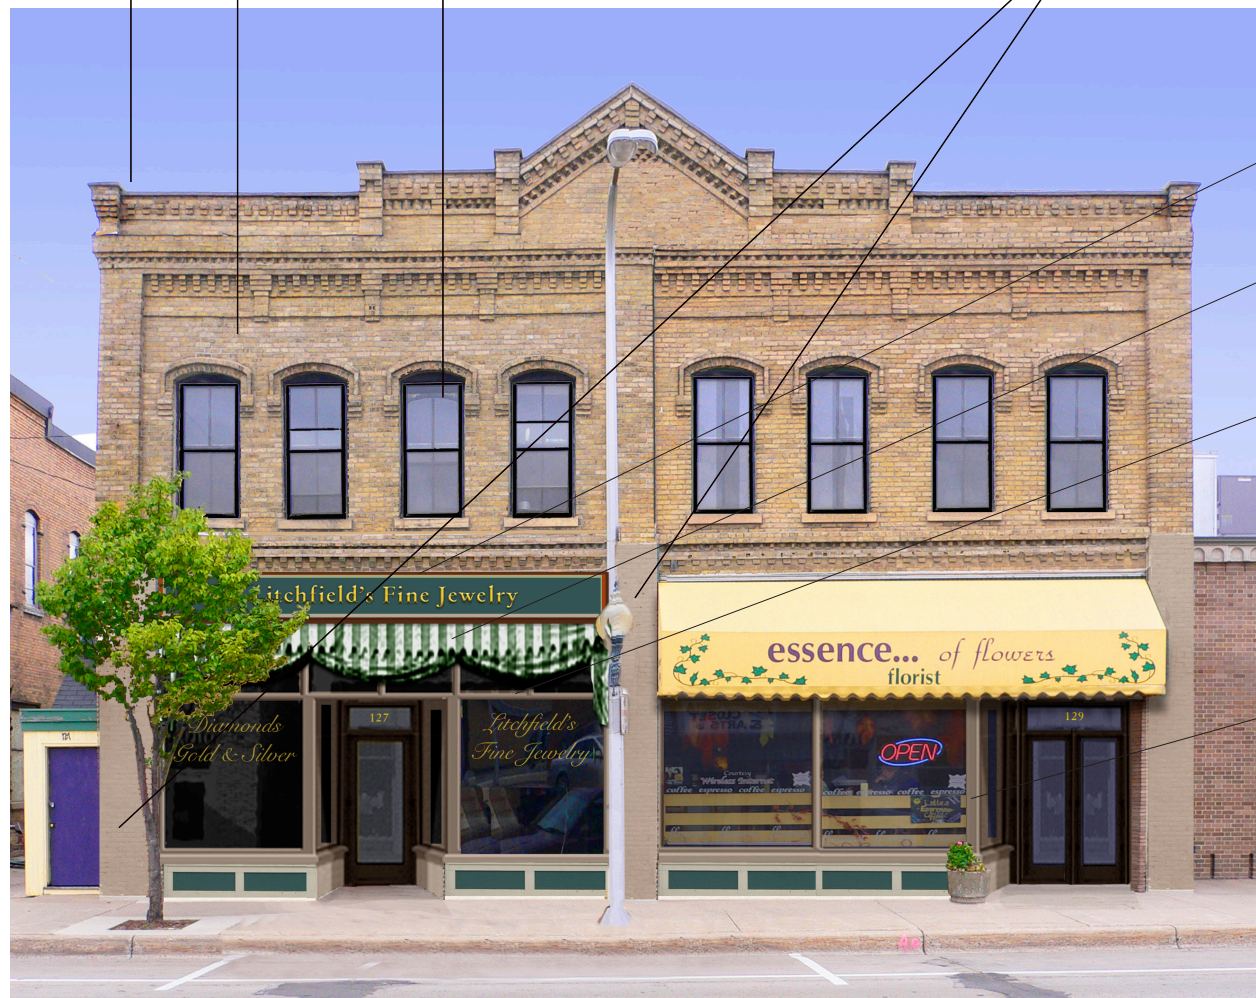
PROPOSED RENOVATION

Consider painting piers that frame storefronts to create a unifying and coordinated appearance.

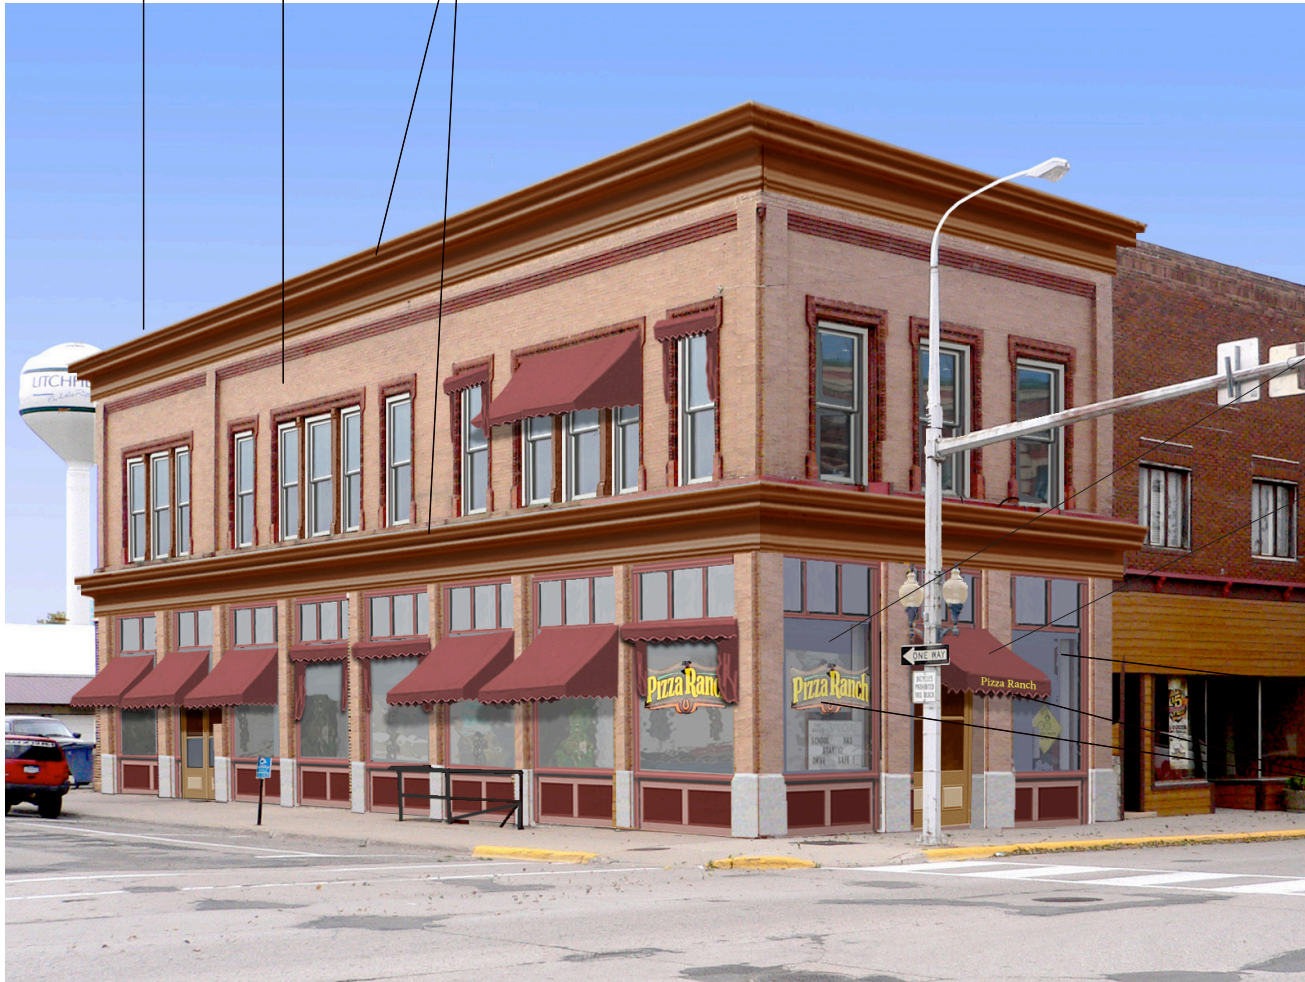
EXISTING CONDITION

This two-story building, constructed ca. 1895 is faced with reddish-brown brick and was designed in a commercial version of the Queen Anne style. It has been altered considerably at the first story with a circa 1980 brick storefront and a brick-faced concrete block addition to the north.

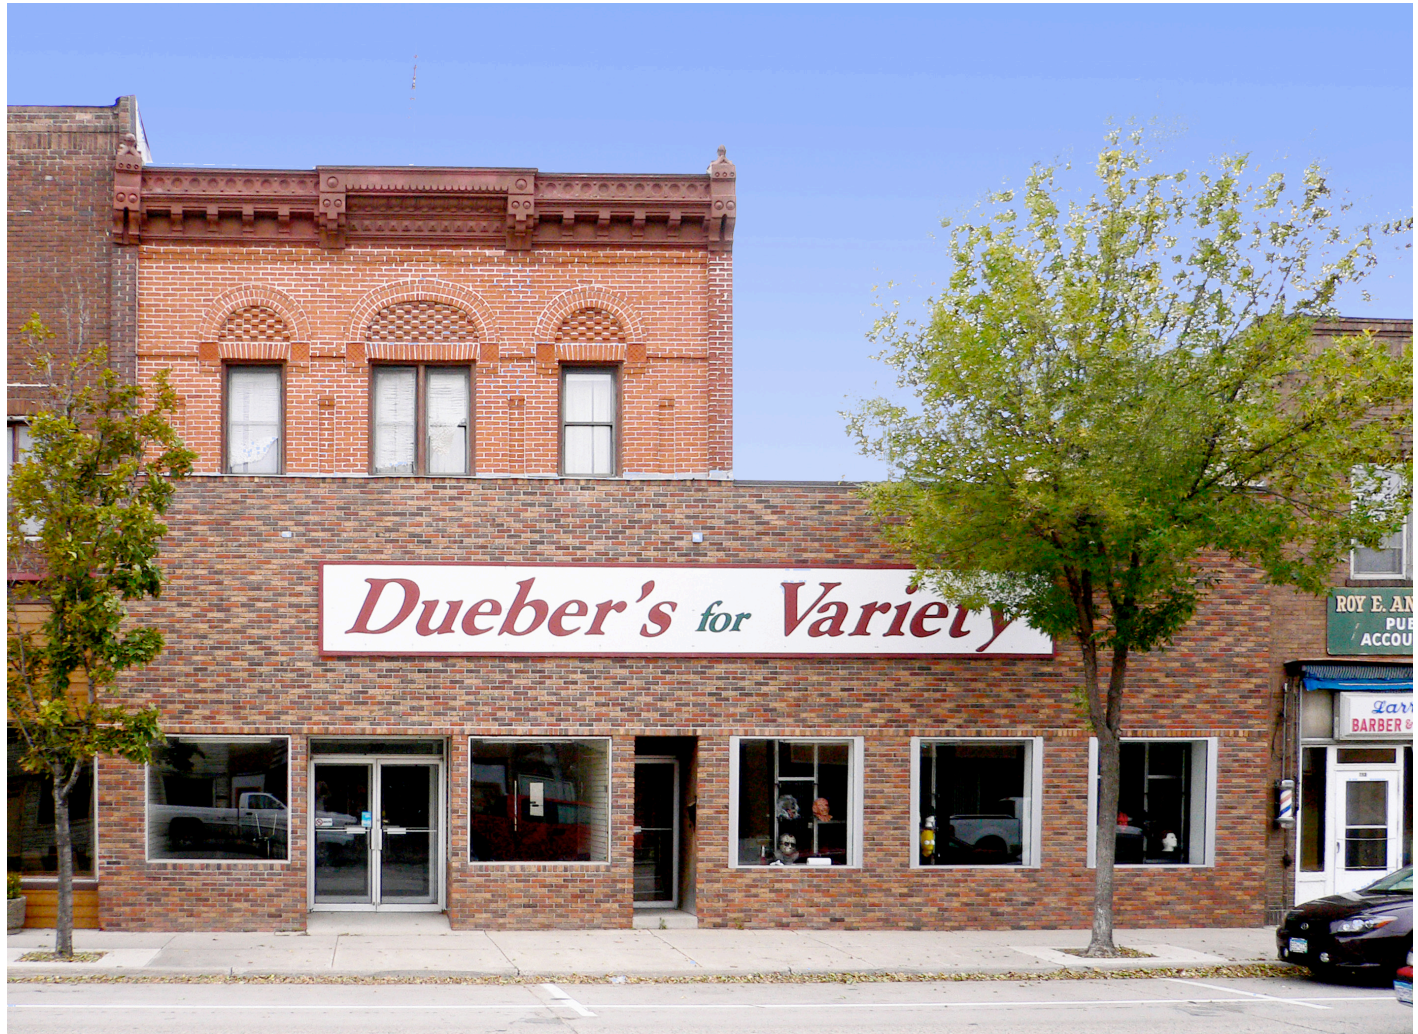
This loss of structural form and architectural integrity was a common occurrence in 20th century historic downtowns as larger store footprints attempted to create a business identity by combining two or more storefronts into one, uniform design.

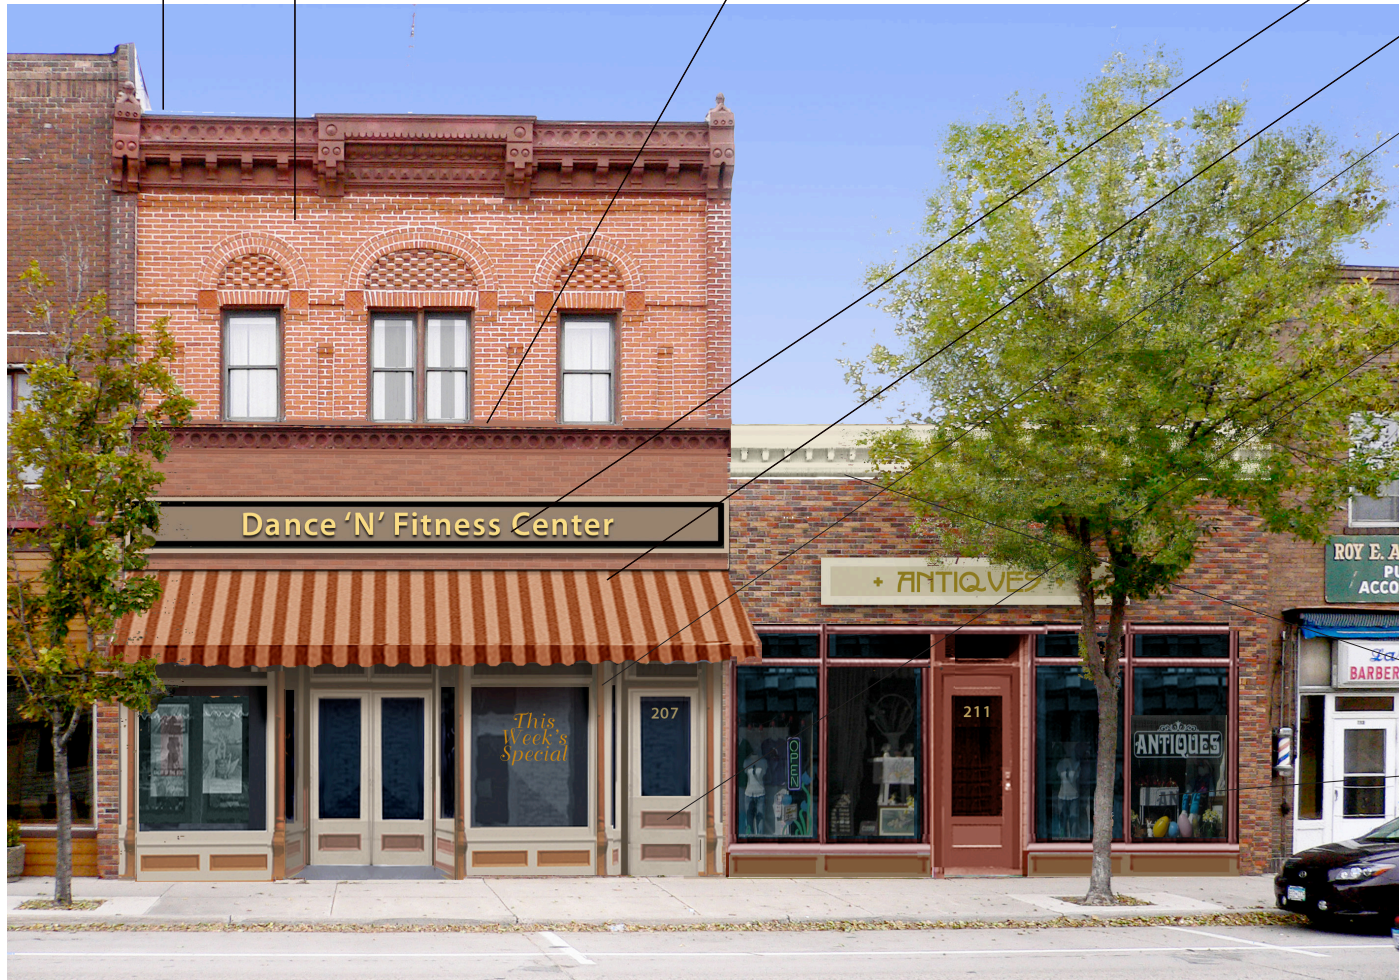
PROPOSED RENOVATION

Introduce simple, but compatible storefront with signboard above.
