Commercial Historic District Design Guidelines for the City of Litchfield Minnesota

Prepared for
The City of Litchfield

Prepared by
Thomas R Zahn & Associates LLC
Spring 2010

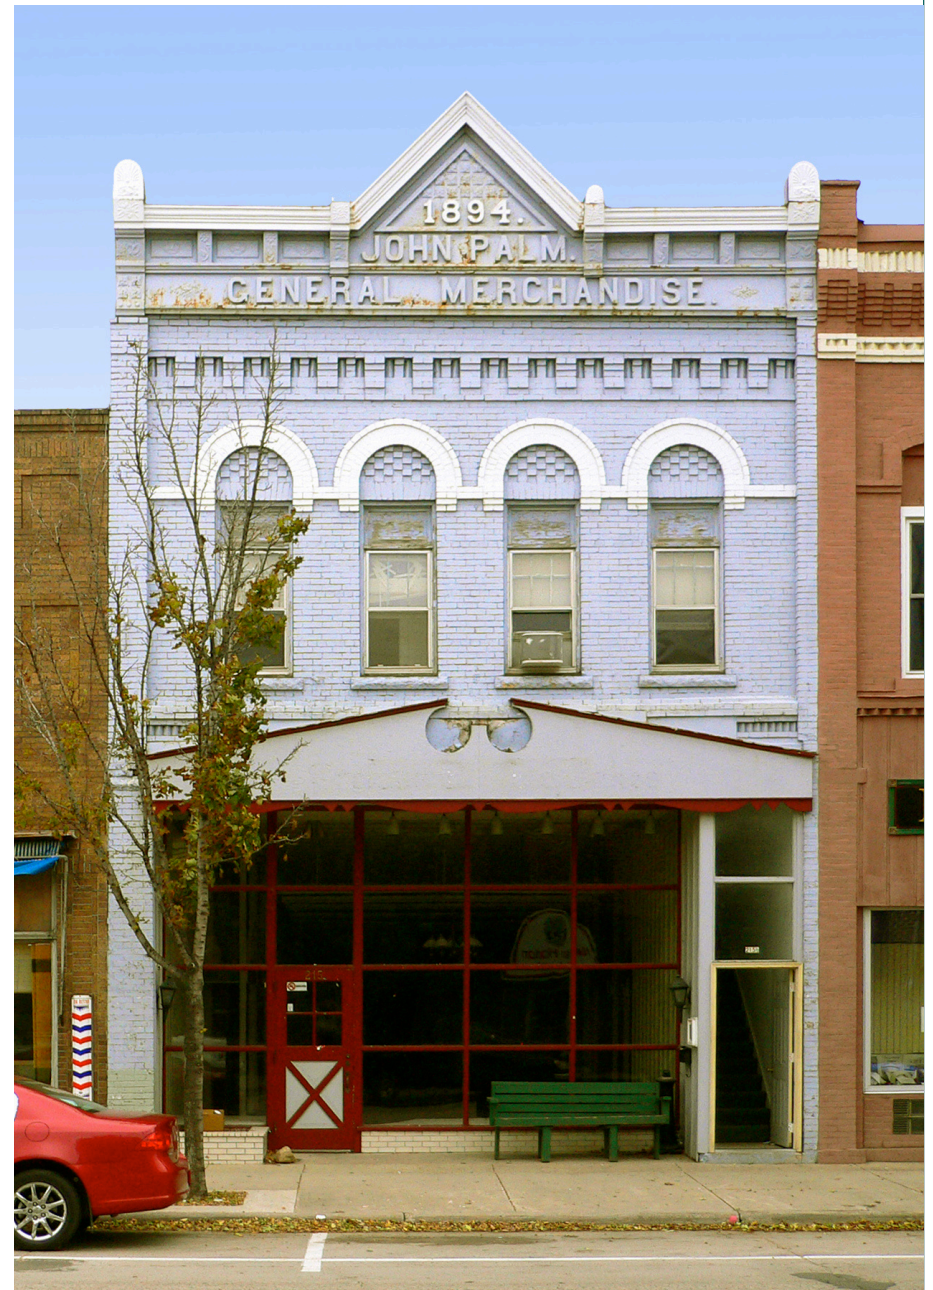
EXISTING CONDITION

To further distinguish the building from its neighbors, what remains of the original main elevation has been painted a light violet with white trim.

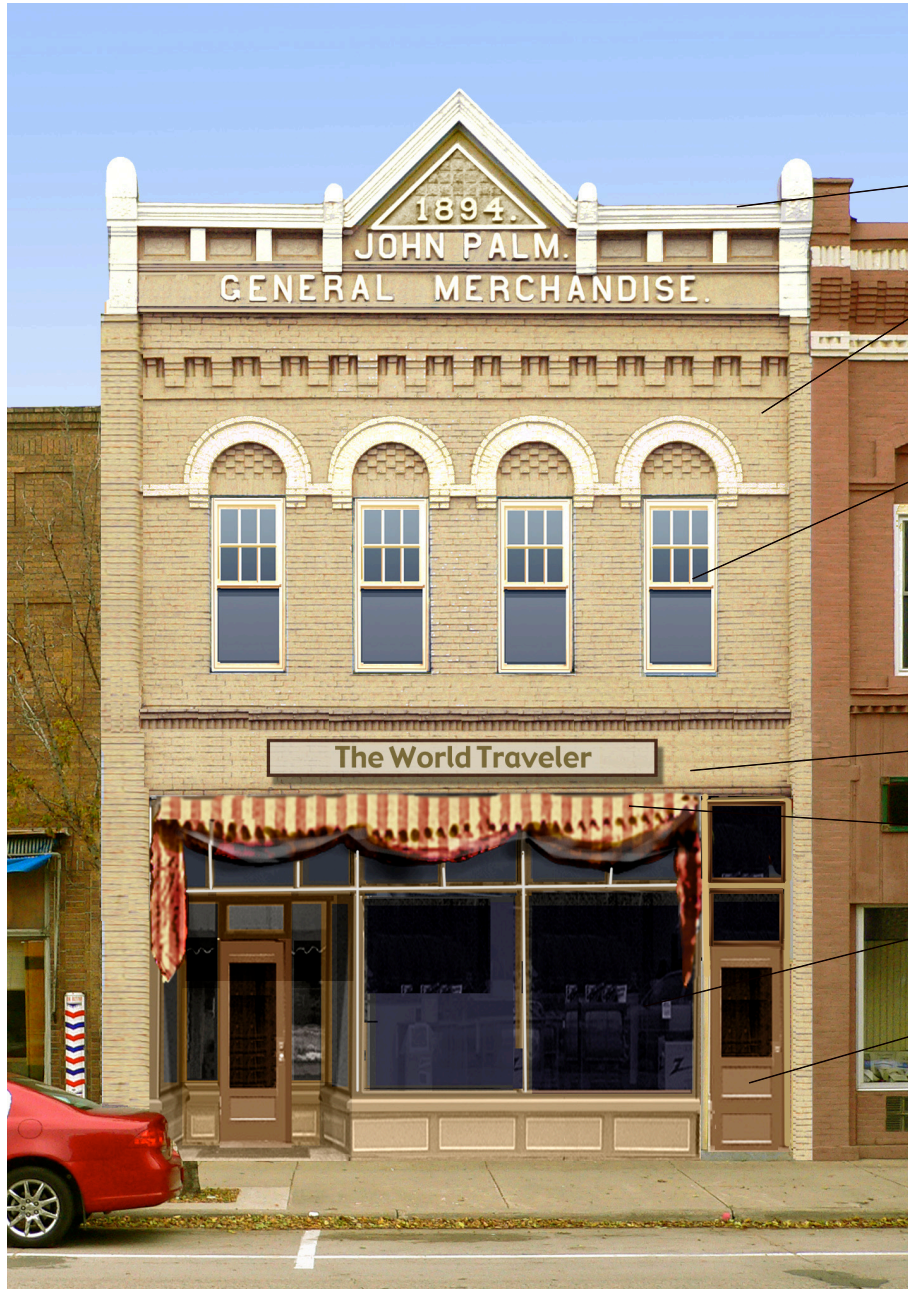
PROPOSED RENOVATION

Inspect roofing, coping and flashing.

Clean and repair brick as necessary.

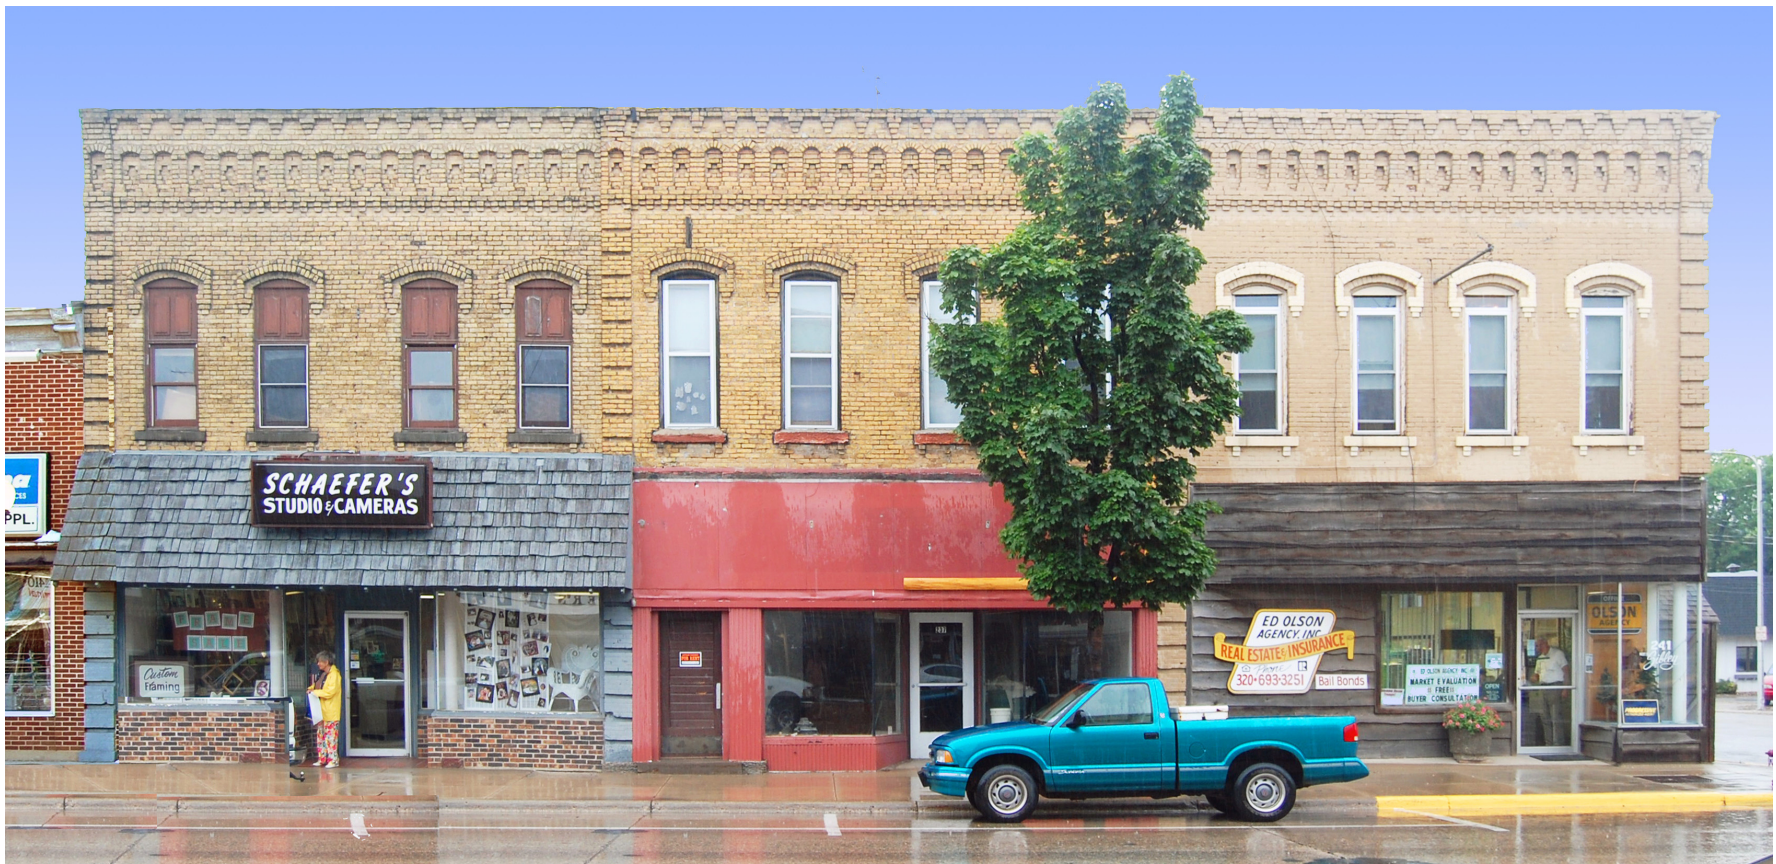
While the upper story generally retains its architectural integrity, the lower storefronts have gone through a variety of changes over time. In an attempt to create individual commercial identities, the storefront compositions of cedar shakes, horizontal wood siding, brightly painted wood panels, infill modern brick, and modern extruded-aluminum framed windows and doors have destroyed continuity at the pedestrian level.

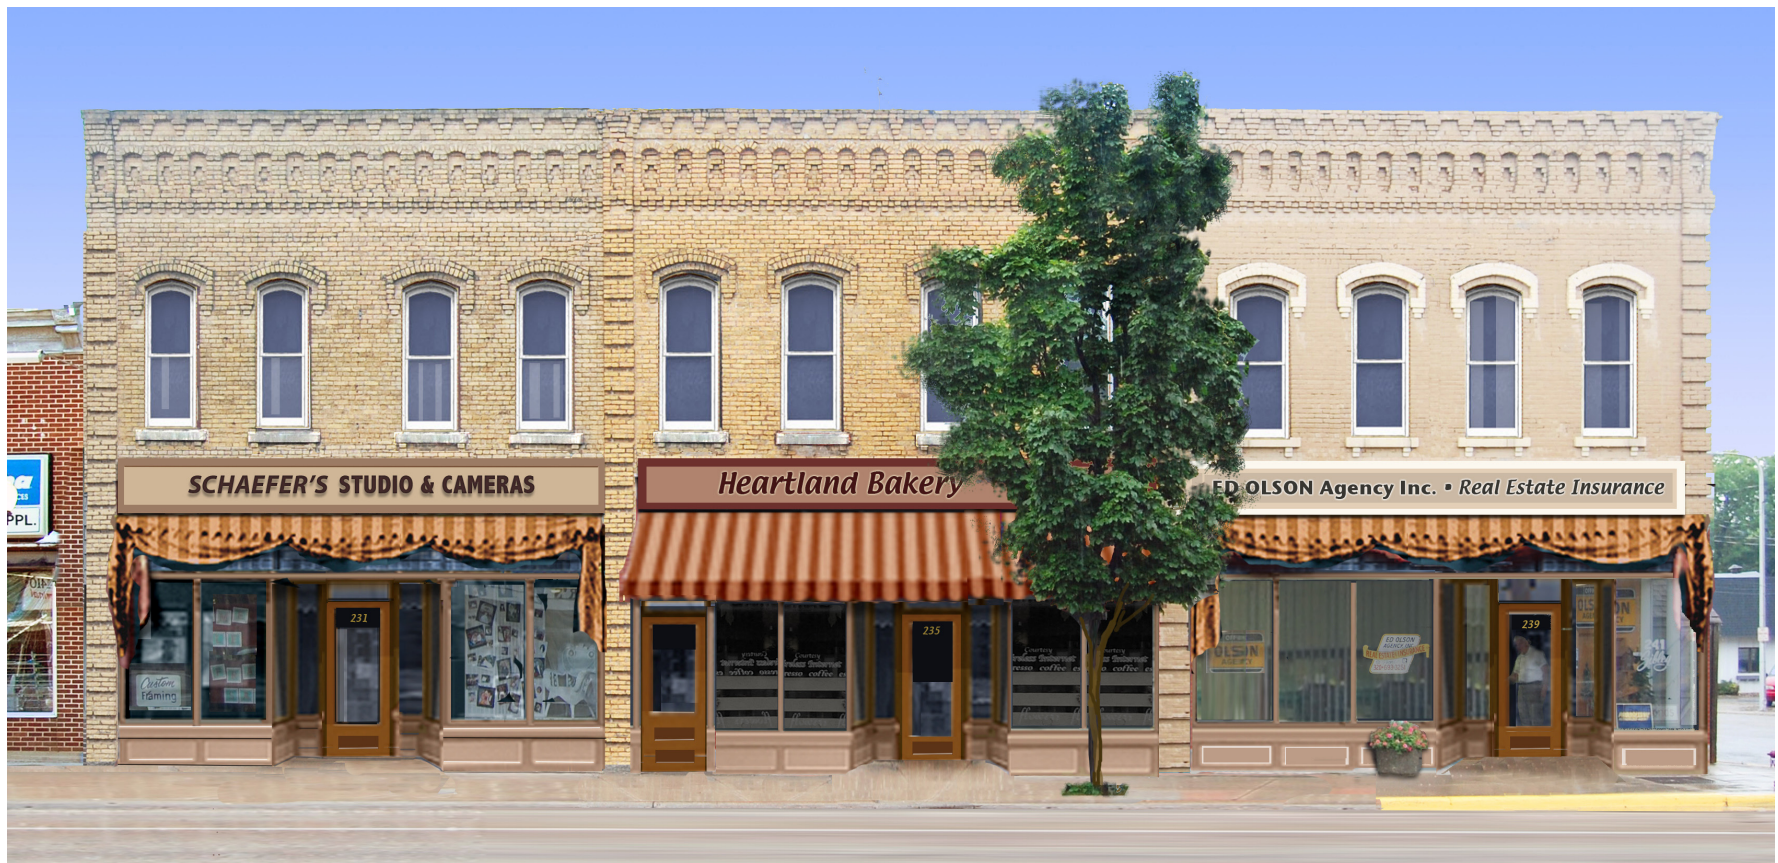
PROPOSED RENOVATION

Install at the 2nd floor entry wood-and-glass door that compliments new storefronts, yet suggests different use than commercial doors.
